MS1200 Oil in Water Monitor Protects Water Treatment Plant from Spill

FULL STORY

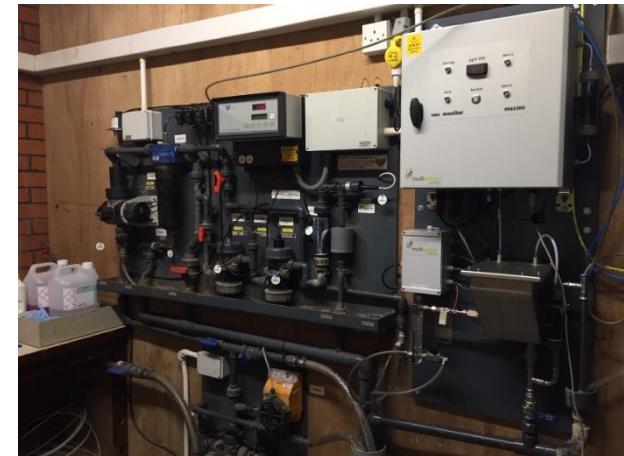
The response of the system is shown below. The level would have continued to rise had the pumps not been turned off quickly.

The original spillage was from dumped oil. The oil entered a local water course and then travelled downstream to the canal. After entering the canal, the oil then travelled a further 3.5 km, undetected, until it reached the intake at 20:30 approximately on 11th November 2018.

The MS1200 is connected directly to a bank of relays which switched off the pumps.
